HGV CAB STRENGTH

Cranfield Impact Centre Ltd.
UK

Paper No. 215

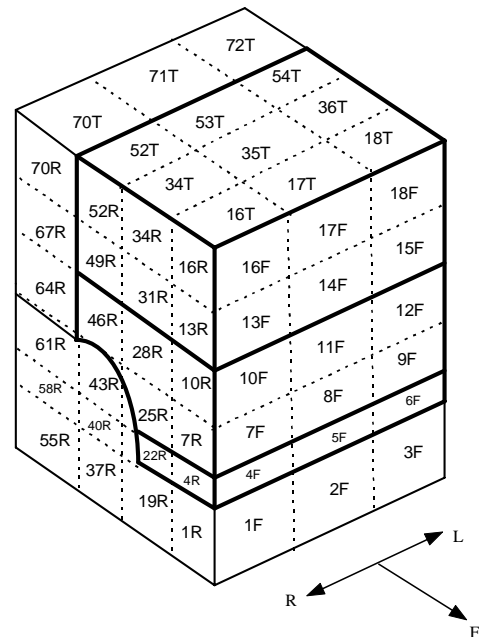
The complete volume of the cab, regardless of its size, was divided into a 'grid' of numbered cuboids as shown in Figure 1. Across the width of the cab, the grid divided the cab into three equal parts. In side view, the cab was also divided into three segments of equal width. For cabs that had a sleeper compartment, an additional set of volumes was included, (numbered 55 to 72).

Figure 1. Cab reference system for analysing cab intrusion.

The grid system in Figure 1 was also used to record the amount of deformation of the cab from the photographic evidence and written text.

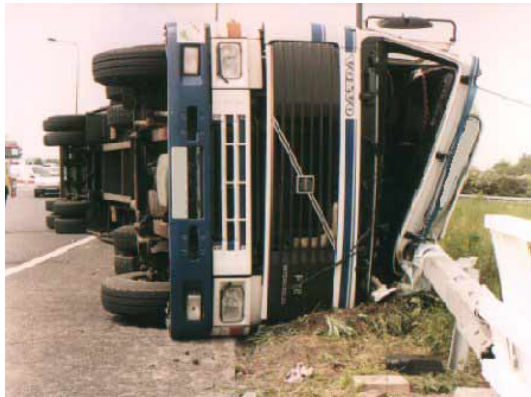
Figure 2. Typical overturned cab accident.

These constituted the largest accident category with 63 cases. In 38 of these, overturning resulted from the HGV running off the road. It is believed that driver fatigue and falling asleep was significant in this respect. Furthermore, 14 cases of overturning were due to 'dynamic instability' where the HGV toppled-over due to its lack of stability. In 3 cases, overturning was caused by the separation of a road wheel. In 45 out of 63 cases, the HGV rolled onto its side and in 16 cases it rolled onto its roof. Of the 26 cases where the HGV impacted a crash barrier, in 18 of these, the HGV overturned as a result of impacting the barrier. The relation of crash barrier performance to HGV overturning is worthy of further consideration.

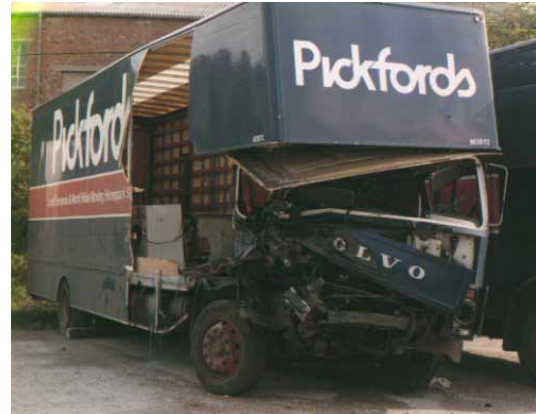
Figure 3. Typical accident involving impact with an on-coming vehicle.

opposing traffic was not physically segregated. Typical of such cases was where one or other HGV lost control on a bend to some extent and impacted an on-coming HGV. The front or side of the 'other' HGV were the areas that struck the cab of the 'subject' HGV most frequently in this study.

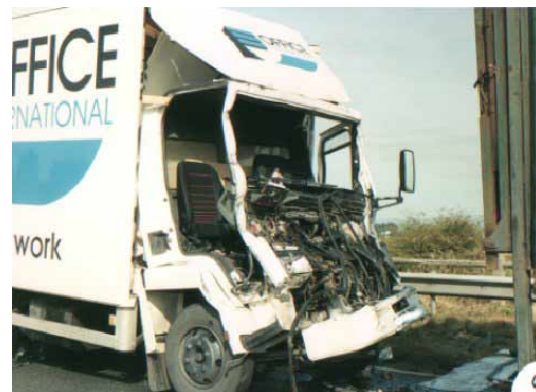
Figure 4. Typical accident involving impact with the rear of a stationary vehicle.

motorways and dual carriageways (36 cases). In 41 cases, the HGV which was hit, was either stationary (on the hard-shoulder or in a traffic queue - 29 cases), or was slow-moving (due to being a heavy-load or on an incline - 12 cases). The rear of a rigid or articulated HGV load platform, in its various loaded and unloaded states, presented a rigid surface which often intruded severely through the sheet metal and windscreen of the impacting HGV.

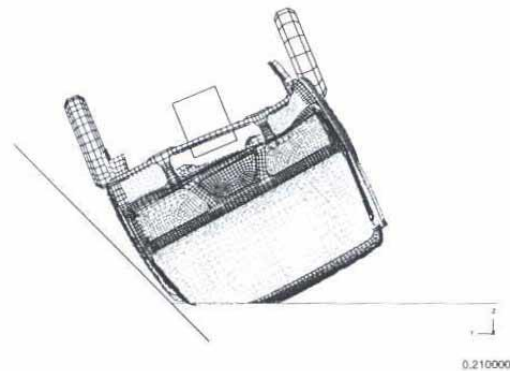
FE computer simulations were carried out for a 'gentle' 180° rollover (ie. down a 45° slope) shown below in Figure 5. The magnitude of the cant-rail load and manner of cab deformation were shown to vary during the rollover phase. The recommended Type Approval test conditions were determined at the time of peak load.

Figure 5. Typical rollover accident simulation.

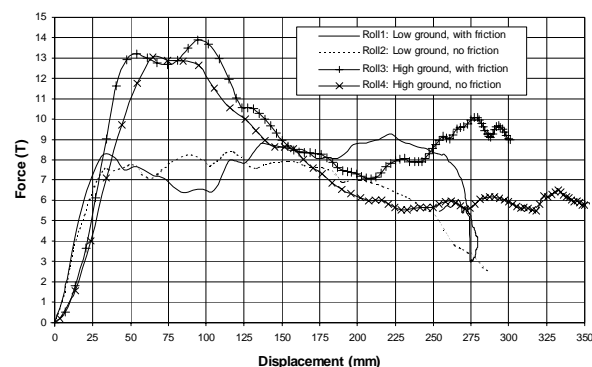
Figure 6. Cant-rail loads v displacement towards survival space for 4 different rollover accident simulations.

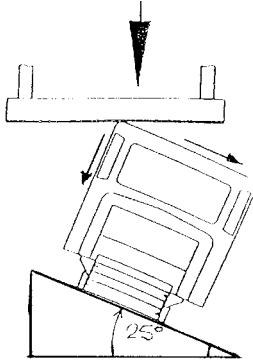
- (b) Proposes that the cab be mounted on the chassis which is rigidly attached to the test bed; the cab is tilted through 25° (driver's side up) about its longitudinal axis and loaded statically by a large flat, horizontal platen (Figure 7). The friction between the cant-rail and platen needs to be minimised.

Figure 7. Proposed roof crush test loading.

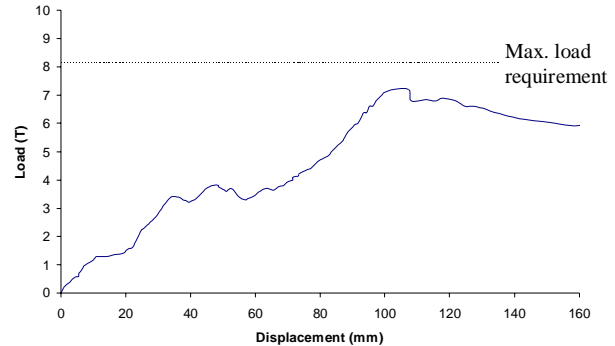
Two roof crush tests were carried out using the conditions outlined in the previous section. The first test was performed on an all-steel cab (Figures 8 and 9).

Figure 8. Load v displacement results for all-steel cab (failed).

The maximum load requirement for each cab is shown as the horizontal dotted line on the displacement graphs. The graphs show that both cabs fall below the proposed standard for the oblique roof crush.

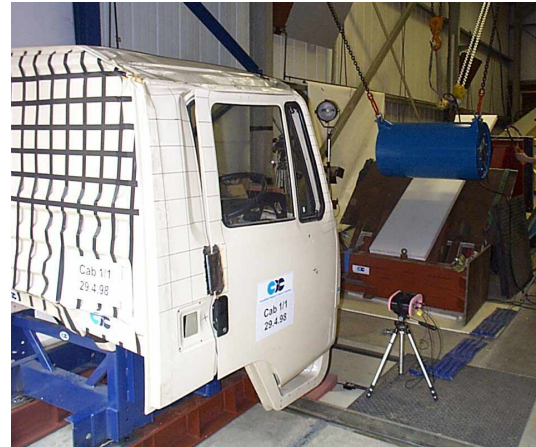
Figure 9. Permanent deformation of all-steel cab after roof crush test (picture shows cab ready for frontal impact test).

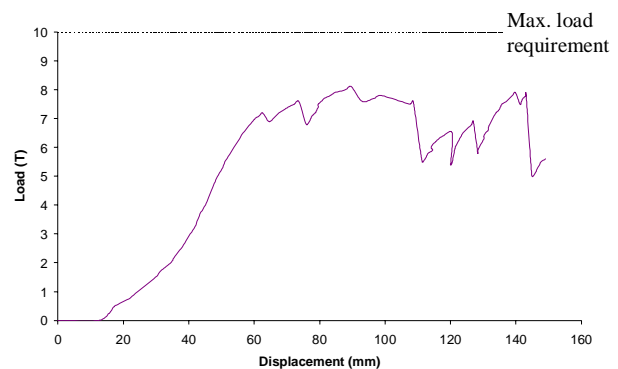
The second test was performed on a slightly larger cab constructed using glass fibre composite panels mounted onto a steel sub-frame (Figures 10 & 11).

Figure 10. Load v displacement results for steel/composite cab (failed).

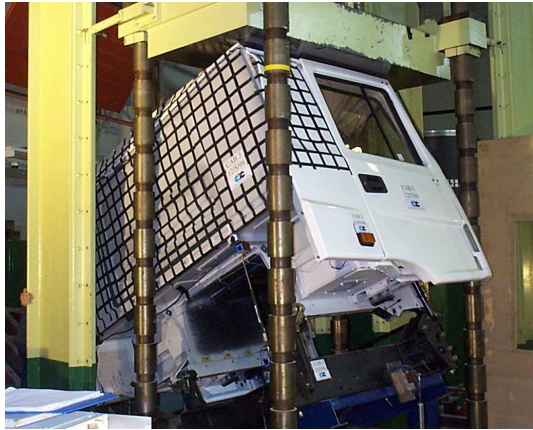
Figure 11. Deformation of steel/composite cab during roof crush test.

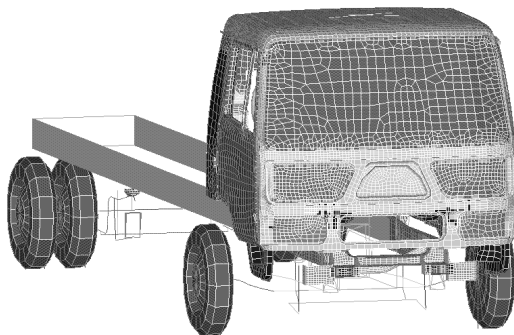
FE computer simulations were carried out for 12 different **frontal impact accident scenarios**. The FE model used for these simulations is shown in Figure 12.

Figure 12. Detailed FE model of HGV for frontal impact accident simulations.

The cab was attached to the chassis via two front and two rear mounts, which were modelled as rigid and non-failing.

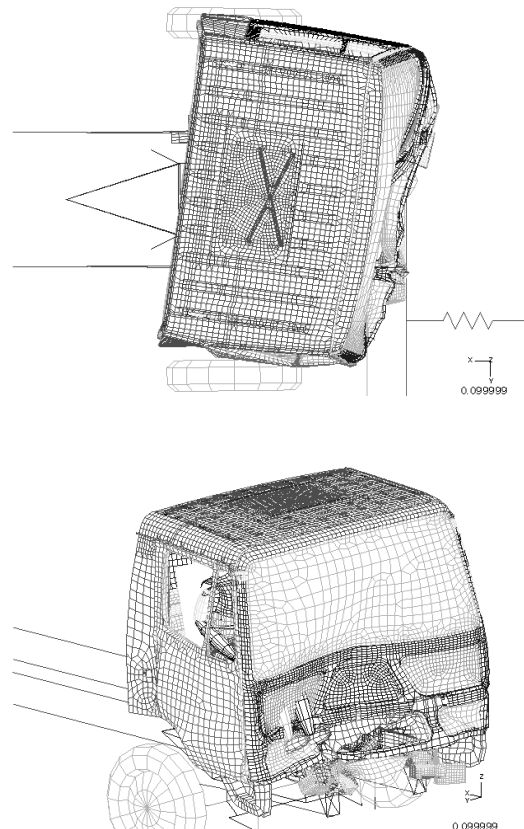
A typical frontal impact simulation is shown in Figure 13. The truck model impacts a simplified model of the rear end of another truck of the same mass, which is free to move upon impact.

Figure 13. Deformed shape of typical frontal impact accident simulation.

The 95%ile Hybrid III dummy was rigidly positioned in the driver's seat. No contact definitions were defined between the dummy and cab, allowing the extent of driver intrusion to be visually monitored.

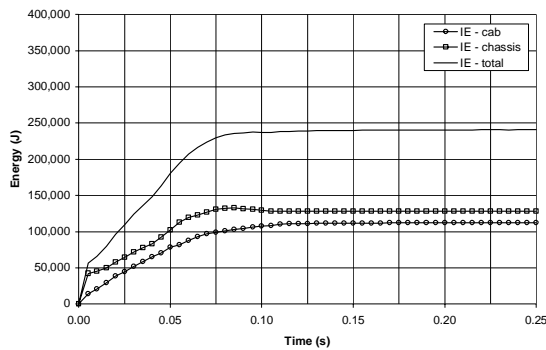
Figure 14 shows the time history plots for the internal energy absorbed by the impacting vehicle. The plot shows the total energy absorbed by the vehicle and also the proportion of energy absorbed by the chassis and the cab.

Figure 14. Energy time history for above frontal impact accident.

The amount of energy absorbed by the cab was used to help determine the magnitude of the impact energy used in the recommended Type Approval test.

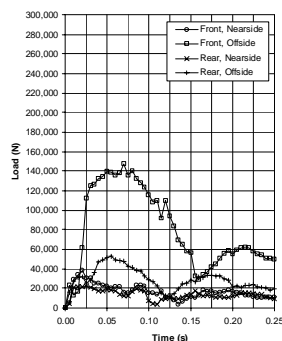
Fig 17. Cab mount loads for cylindrical impactor.

However, it loses its kinetic energy more rapidly than the cylinder and hence creates relatively high loads at the cab-to-chassis mounts (Figs 17 & 18).

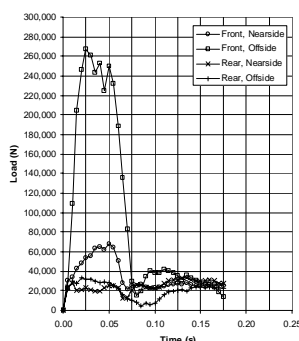
Fig 18. Cab mount loads for flat impactor.

The flat impactor distributes the impact load over a larger area of the cab and is therefore less aggressive to the cab structure.

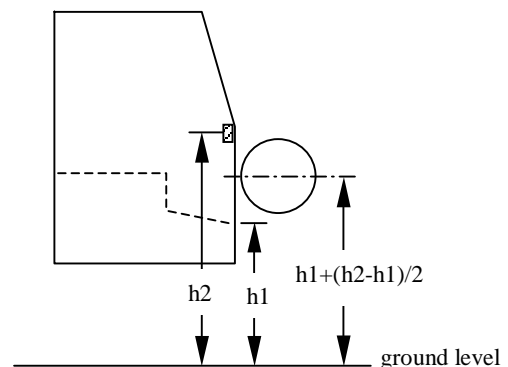
The dynamic impact test consisted of a 1 tonne cylindrical pendulum impactor (chain hung), striking perpendicular to the front of the cab at a 50% offset. The residual space to be left intact was again the 95%ile Hybrid III dummy. The energy of impact = 40kJ.

Figure 19. Proposed frontal impact test.

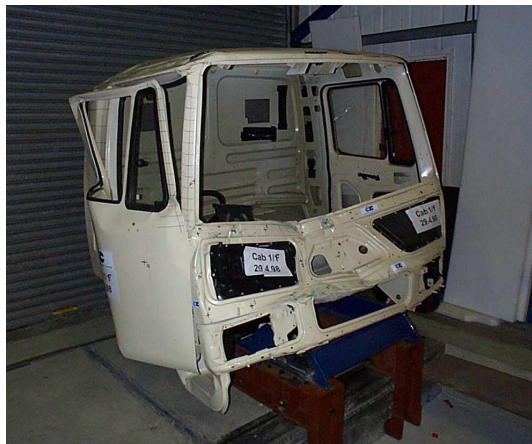
Figure 20. All-steel cab, rigid mounts, 20kJ.

Cab strengthening measures were recommended due to the initially poor performance of the all steel 'walkthrough' cab type (Figures 20 and 21). The modifications included reinforcements to the front panel, door, B-pillar, and mounts, and were designed in a commercially feasible manner.

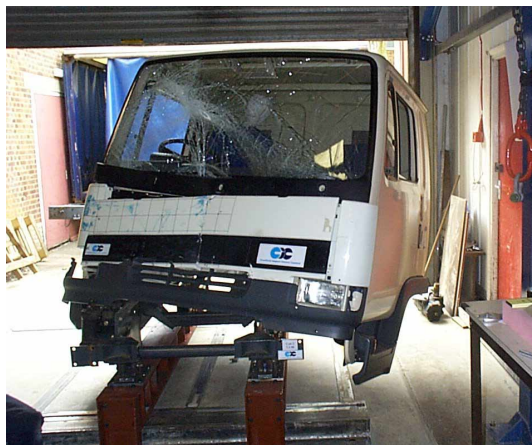
Figure 21. All-steel cab, original mounts, 38kJ.

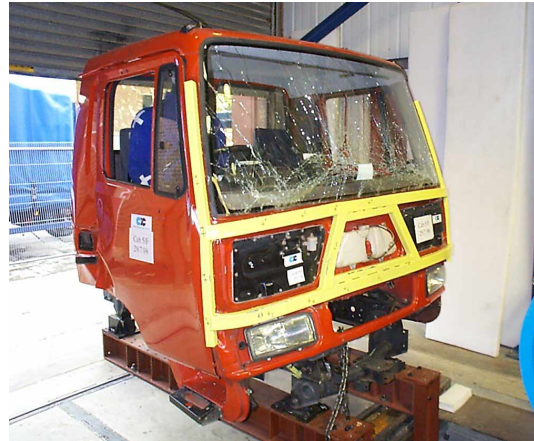
Figure 22. All-steel cab, with strengthening modifications, 40kJ.

The testing phase showed that the cab strengthening methods significantly improved the cab performance with regard to frontal impacts (Figure 22).
